Site Investigations in Sri Lanka

Objective: Site investigations and feasibility studies for installing landslide monitoring instruments at various JICA funded sites in Sri Lanka

Location: Nuwara Eliya, Sri Lanka

Duration: March 20th to March 23rd, 2014

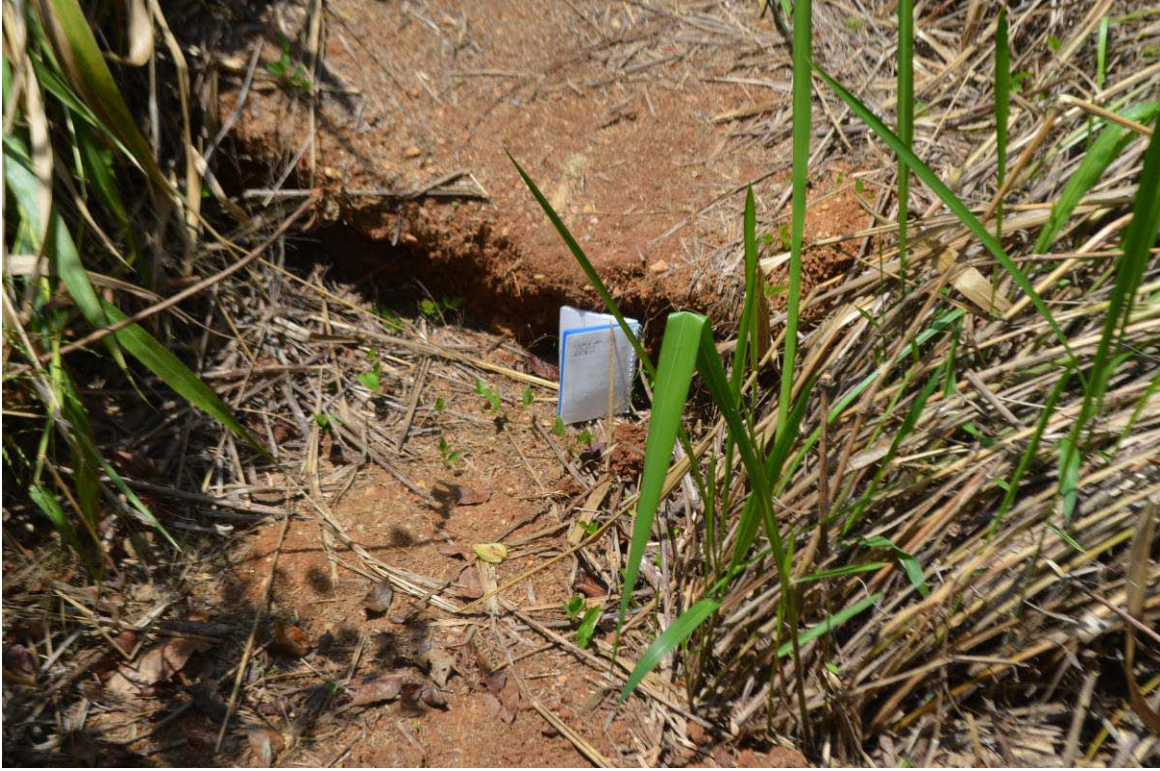
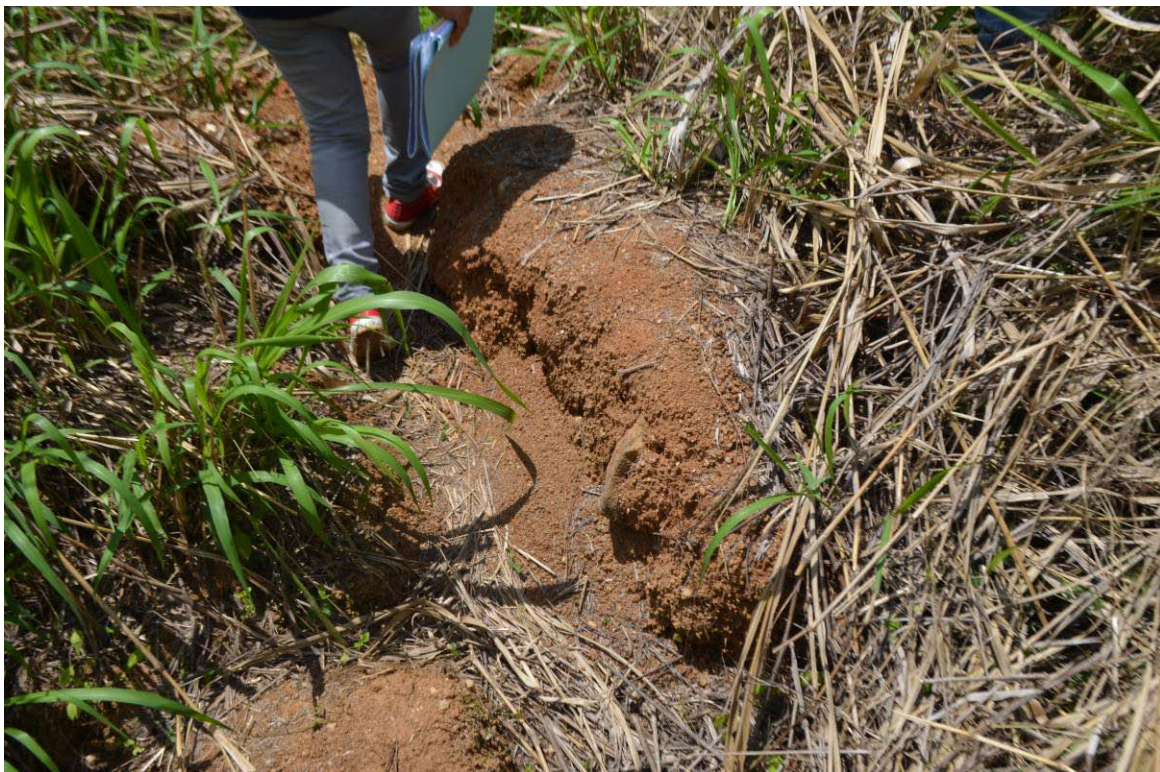
- Overall length of the landslide is quite large as approximately 1 km strip of land appear to be moving.
- Cracks are clearly visible at various locations on the slope surface. Movement of the soil is well beyond 1 m at various such crack locations.

Figure 2: Visible cracks on slope surface.

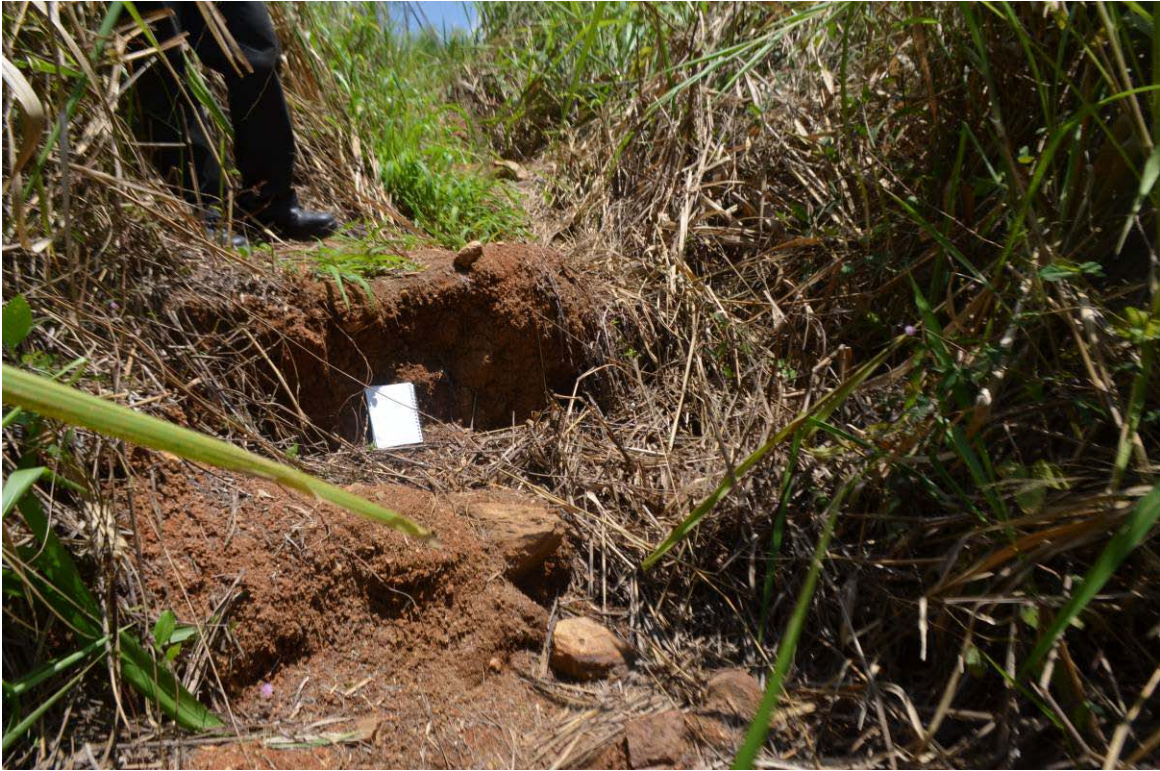
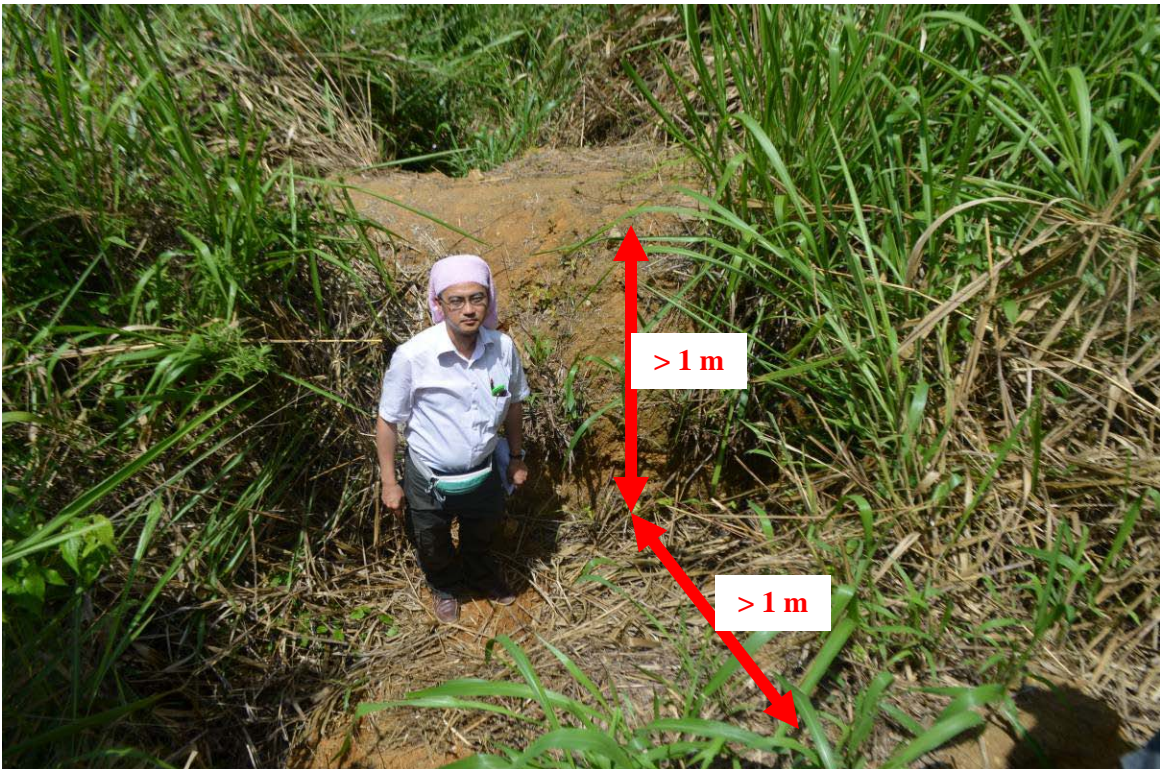
Figure 3: Large cracks and humps formed due to slope movement.

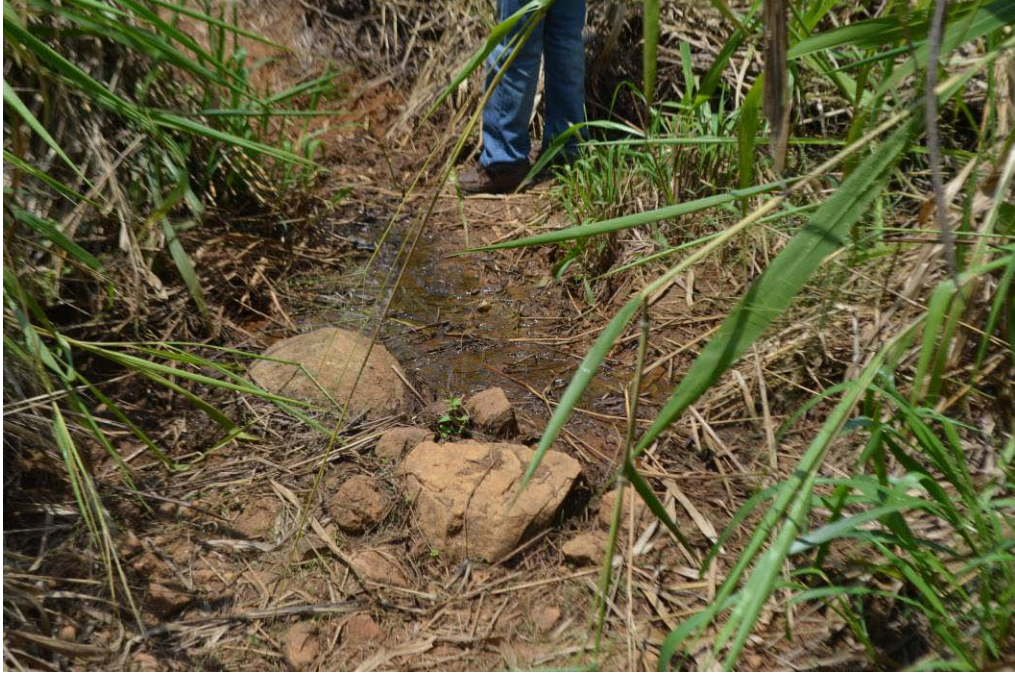
- Ground water table appears to be quite shallow (Fig. 4). Thus even small rainfall can potentially trigger rapid movement.
- Restricting the movement of such a massive slope may not be possible. However, monitoring instruments can help in identifying the risk involved and issue early warning to minimize damages.

Figure 4: Water gushing through the soil.

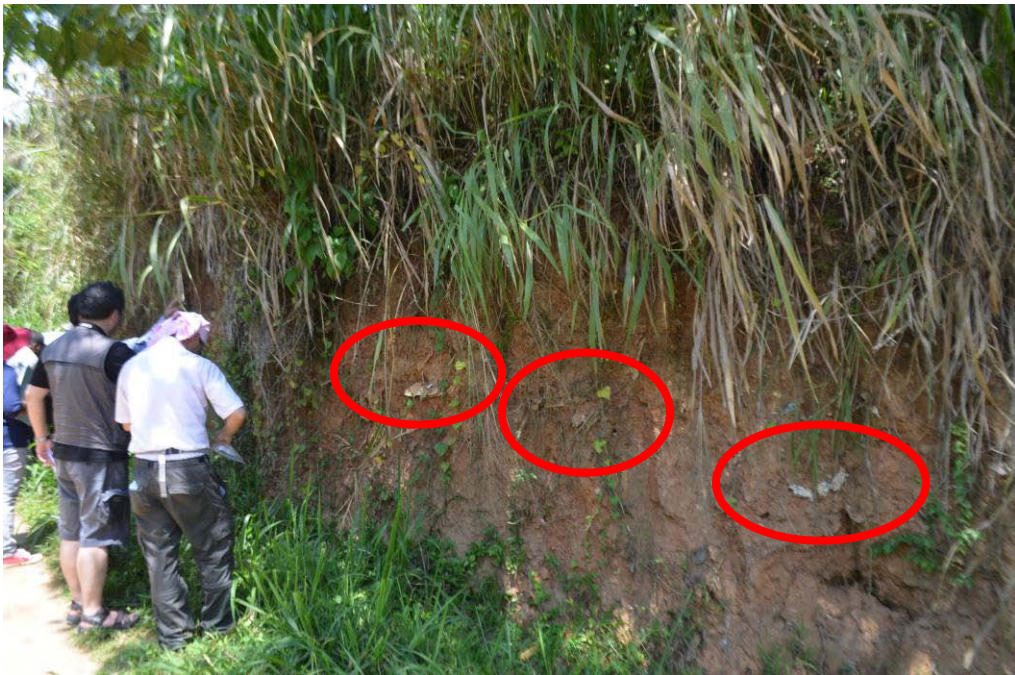
Figure 5: Some debris and plastic waste found in the soil near toe of slope.

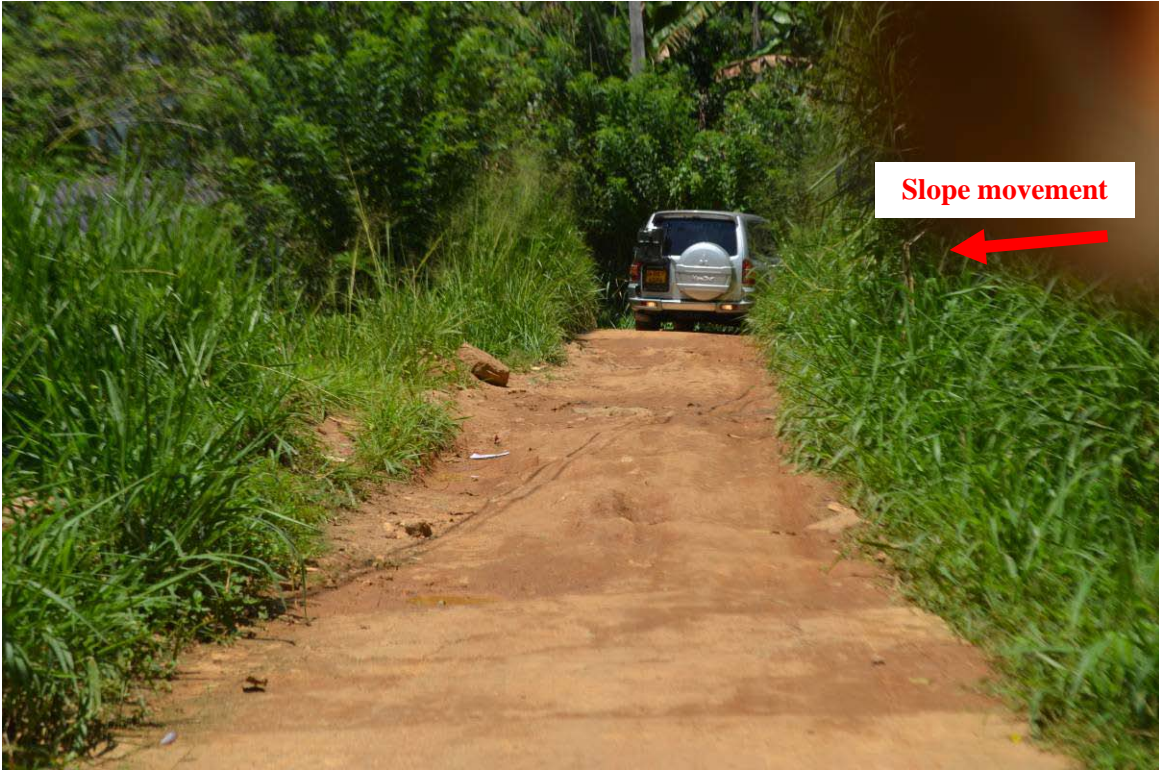
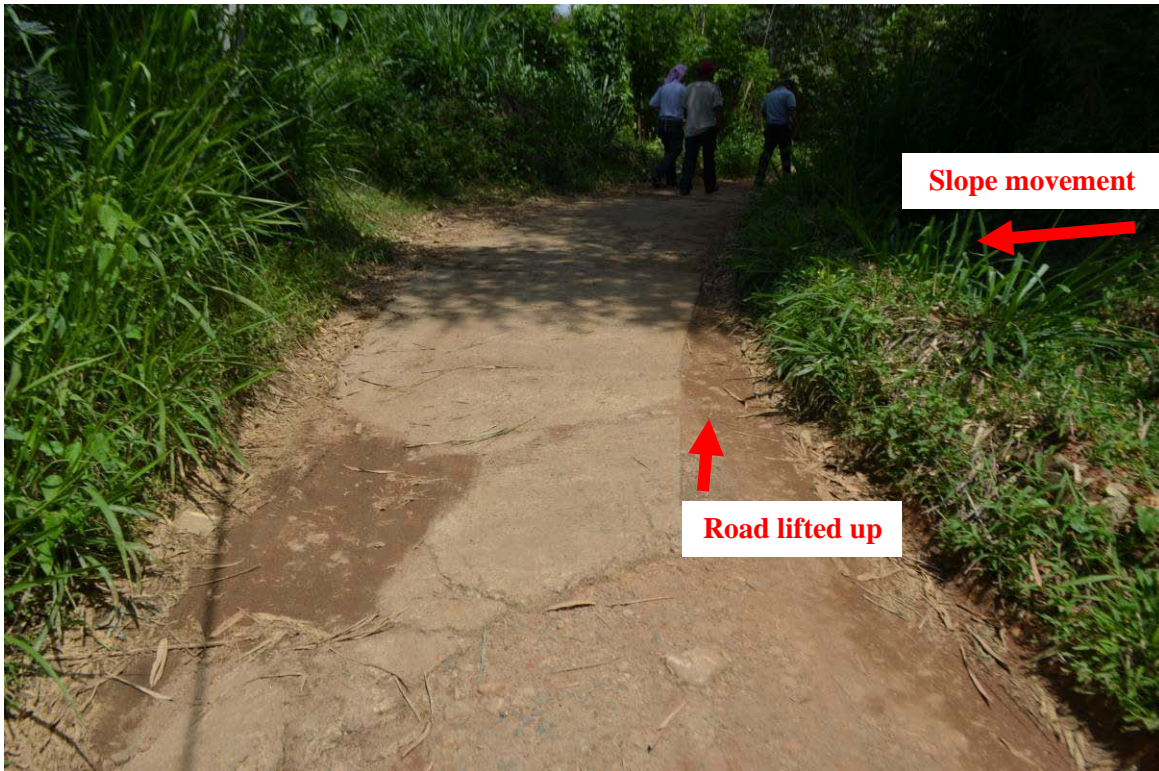
Figure 6: Deterioration of the road near the toe of slope.

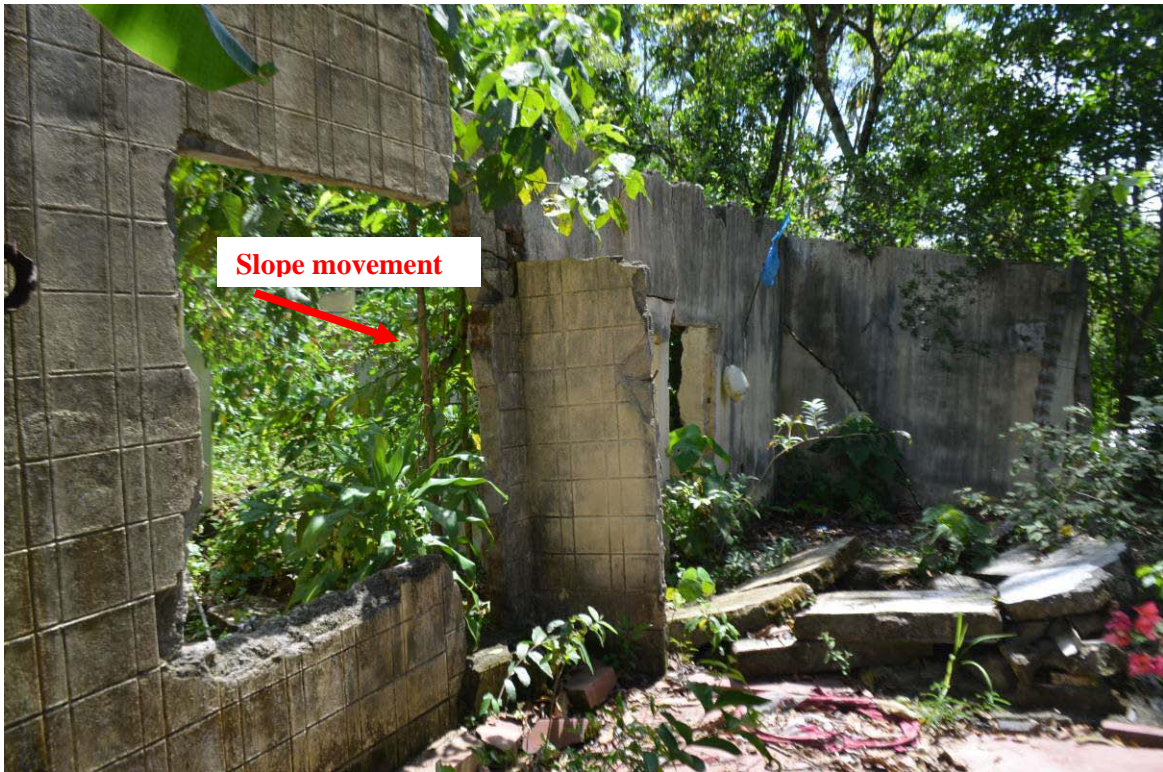
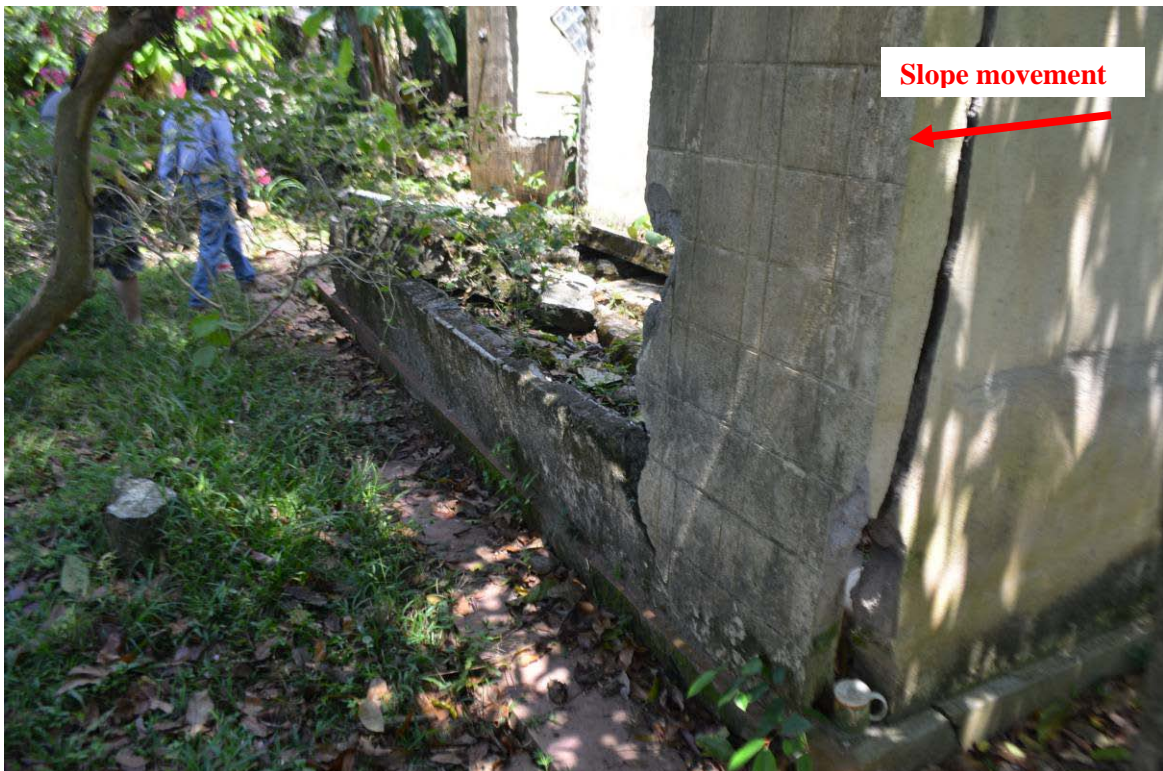
- During heavy rain showers in December 2010 through January 2011, cracks started appearing in several houses situated in the landslide area.
- Until now 16 houses have totally subsided whereas another 20 houses have developed severe cracks.

Figure 7: Damaged houses near the toe of slope.

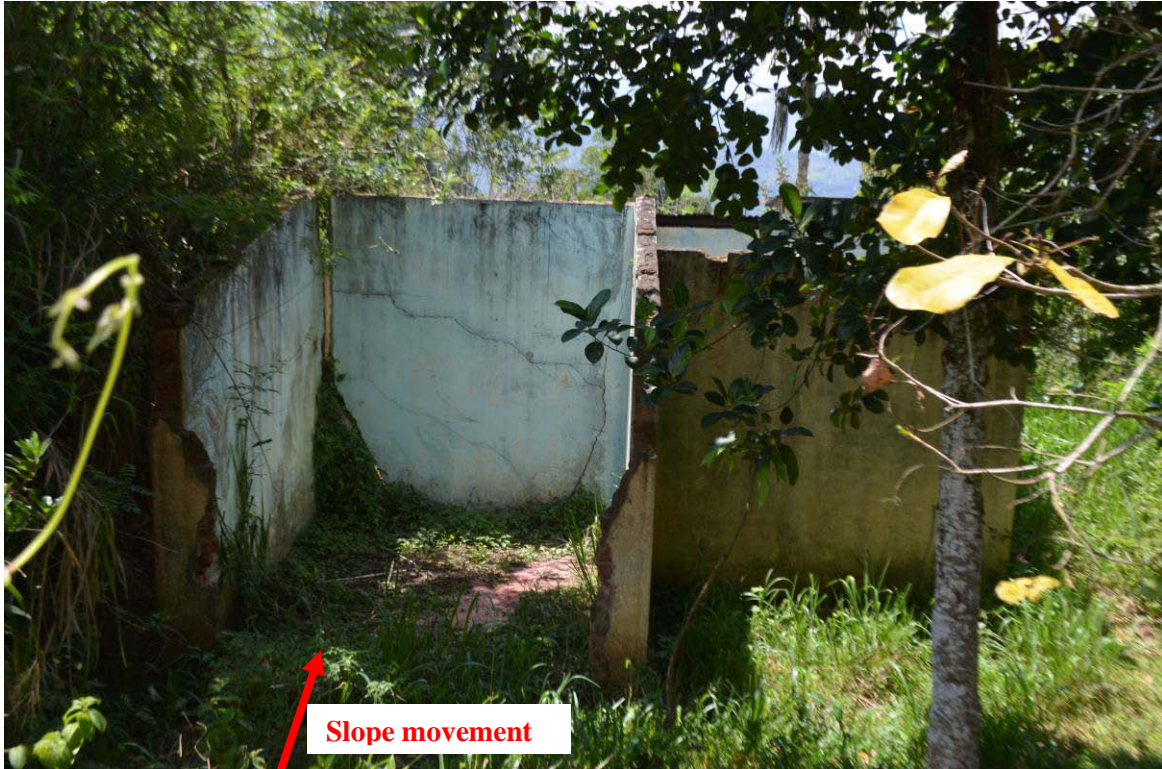
Figure 8: Damaged houses near the toe of slope.

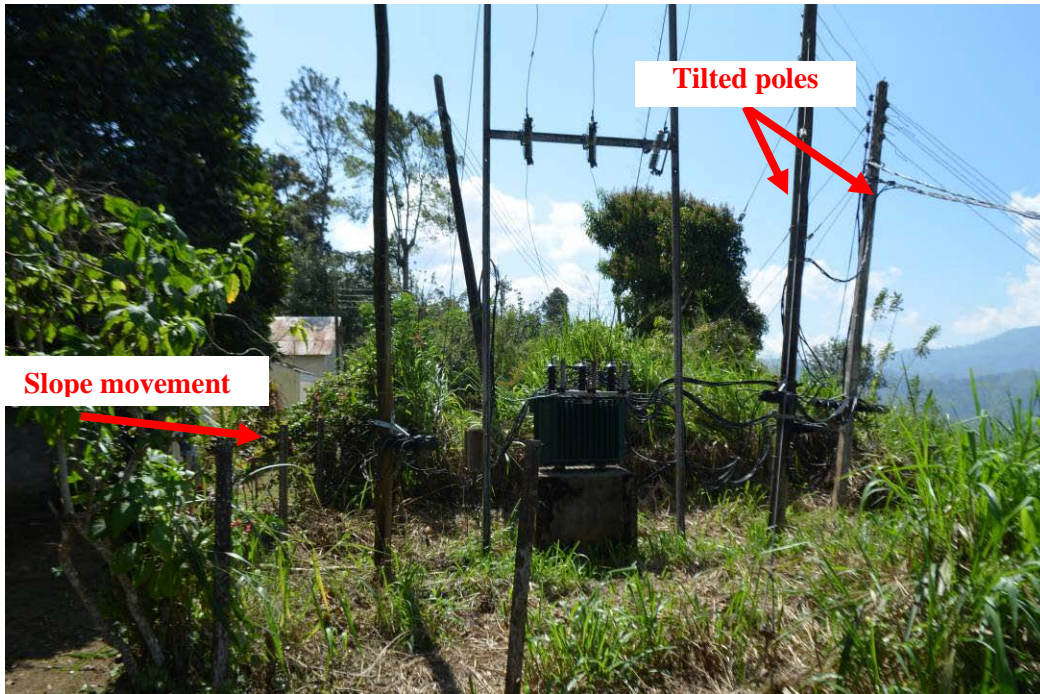
Figure 10: Poles tilted due to ground movement (location: near top of slope, GPS-4 position in Fig. 9)

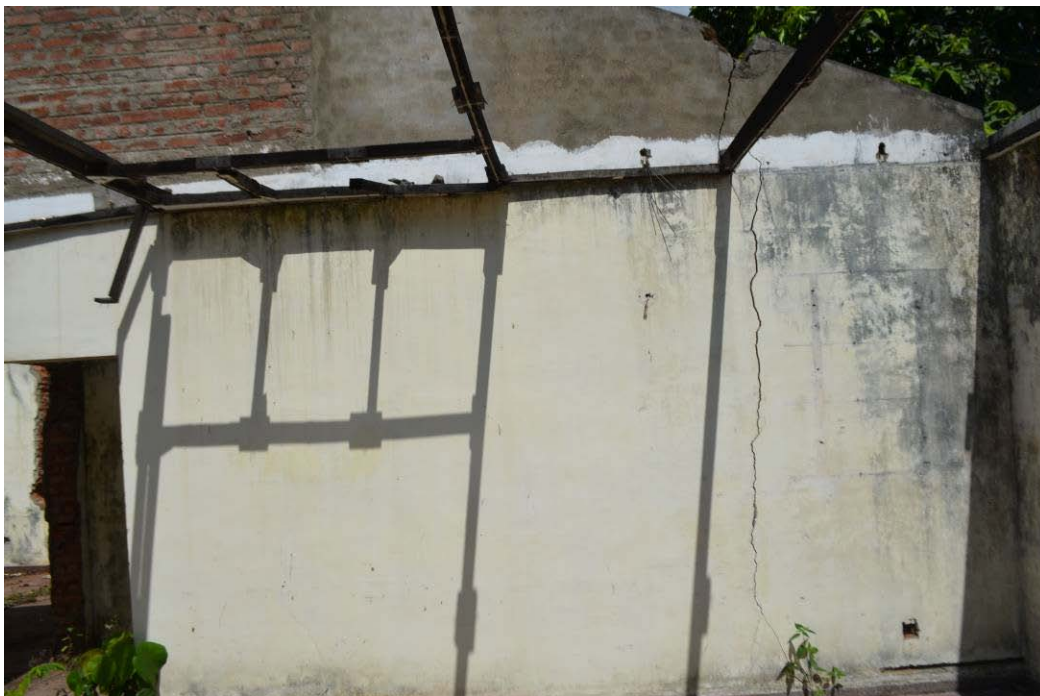
- Failure triggered during December 2010 and January 2011 storms.
- Very high annual rainfall (~ 3500 mm) in this area.
- Very heavy showers (165~170 mm) were observed during the said rainy season.
- Bungalow near the top of slope (location: GPS-4 in Fig. 9) was severely damaged due to slope movements.
- Some parts of the road which is running through the slope surface (location: GPS-2 in Fig. 9) have collapsed due to gradual slope movement.

Figure 11: Cracks in Bungalow building (location: near top of slope, GPS-4 position in Fig. 9)

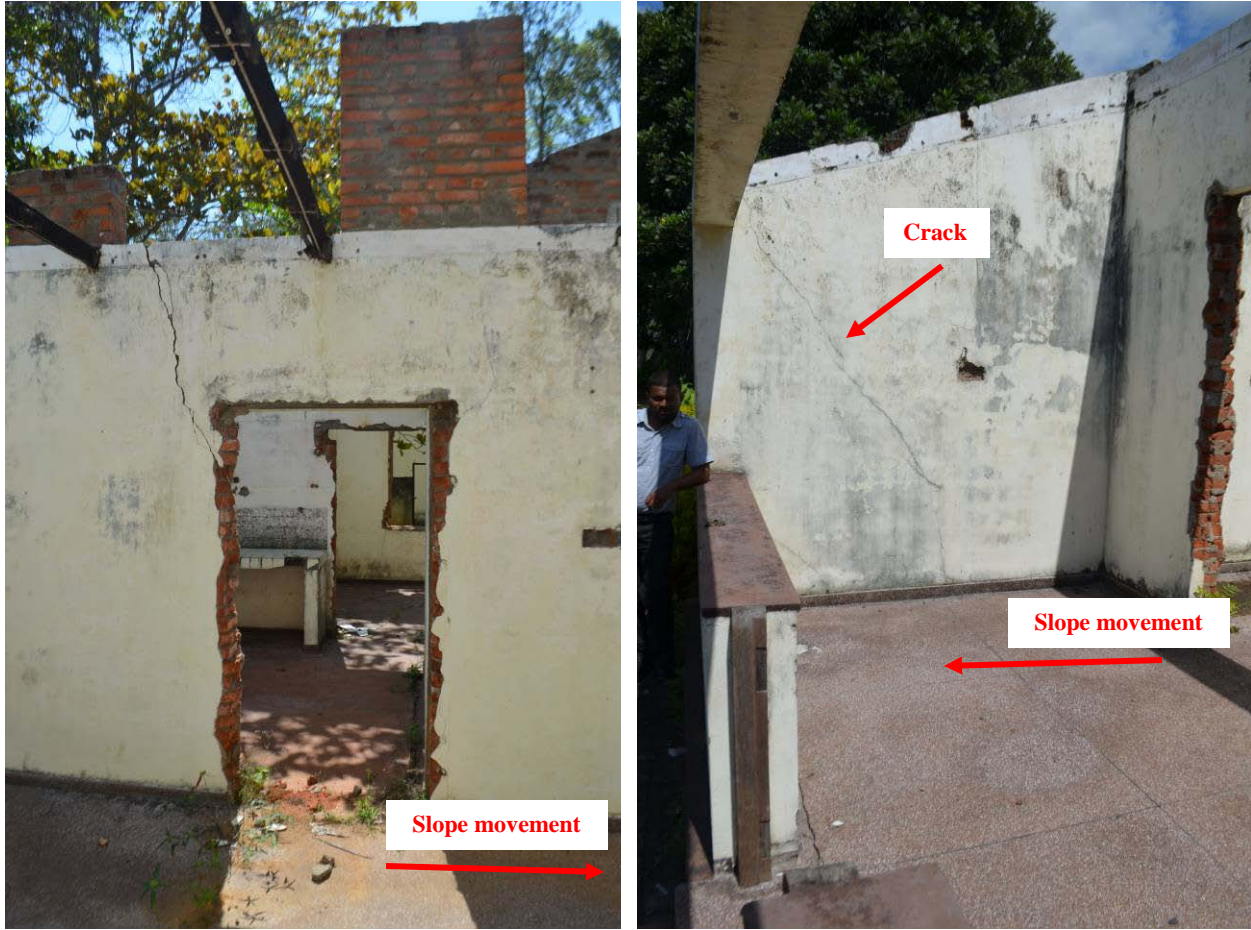
Figure 12: Cracks in Bungalow building (location: near top of slope, GPS-4 position in Fig. 9)

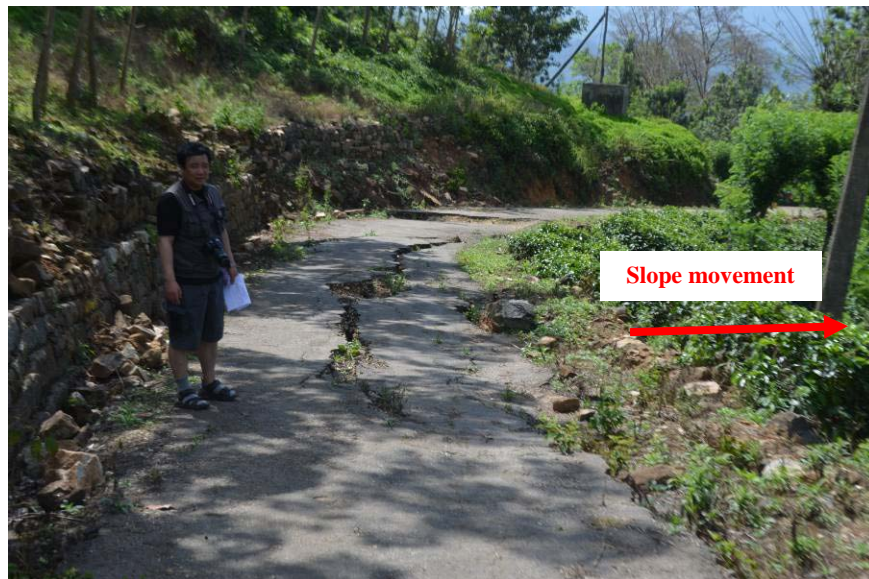
Figure 13: Damage to road along location GPS-2.

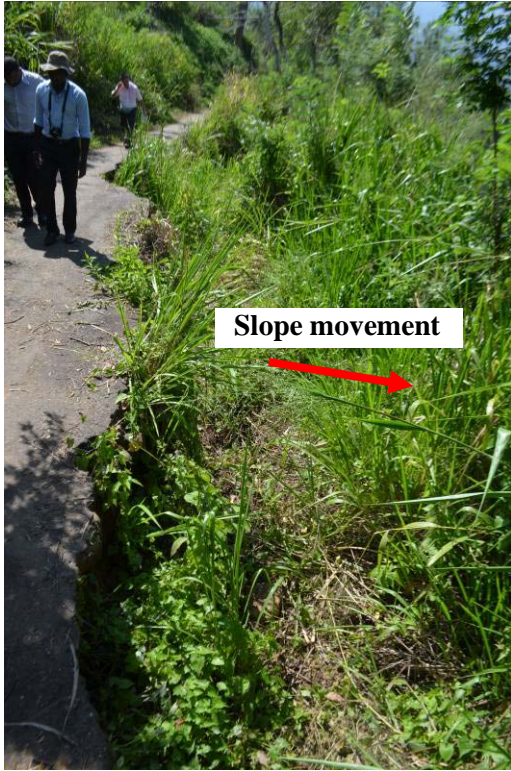
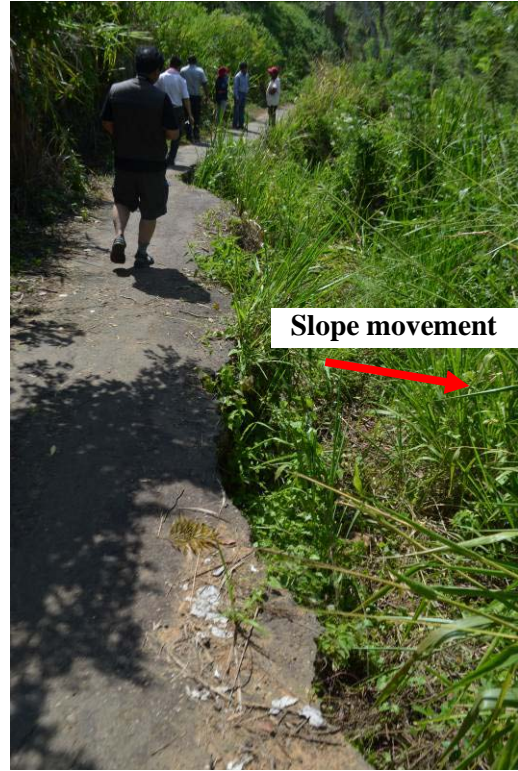
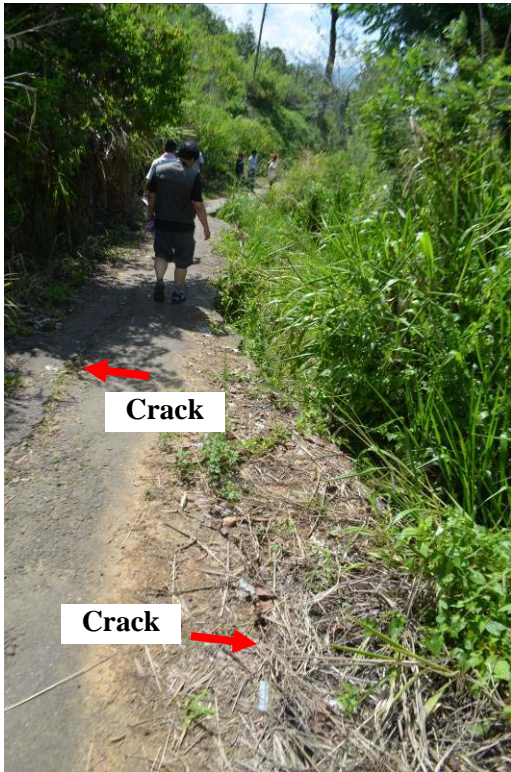
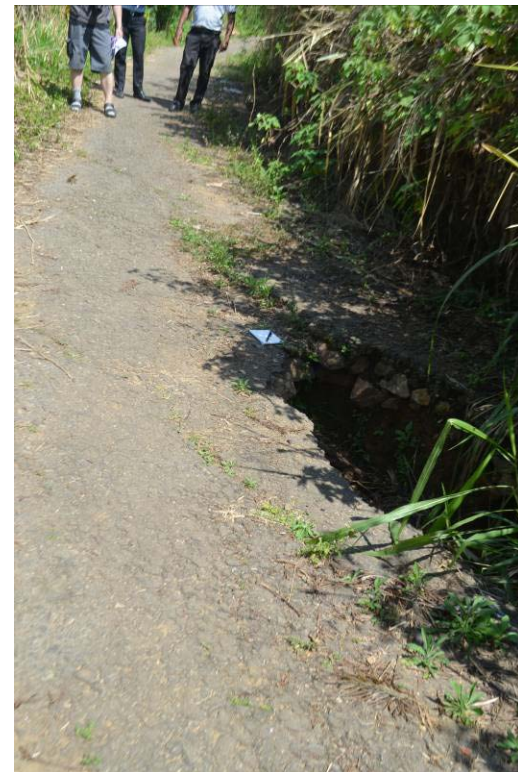
Figure 14: Damage to road along location GPS-2.

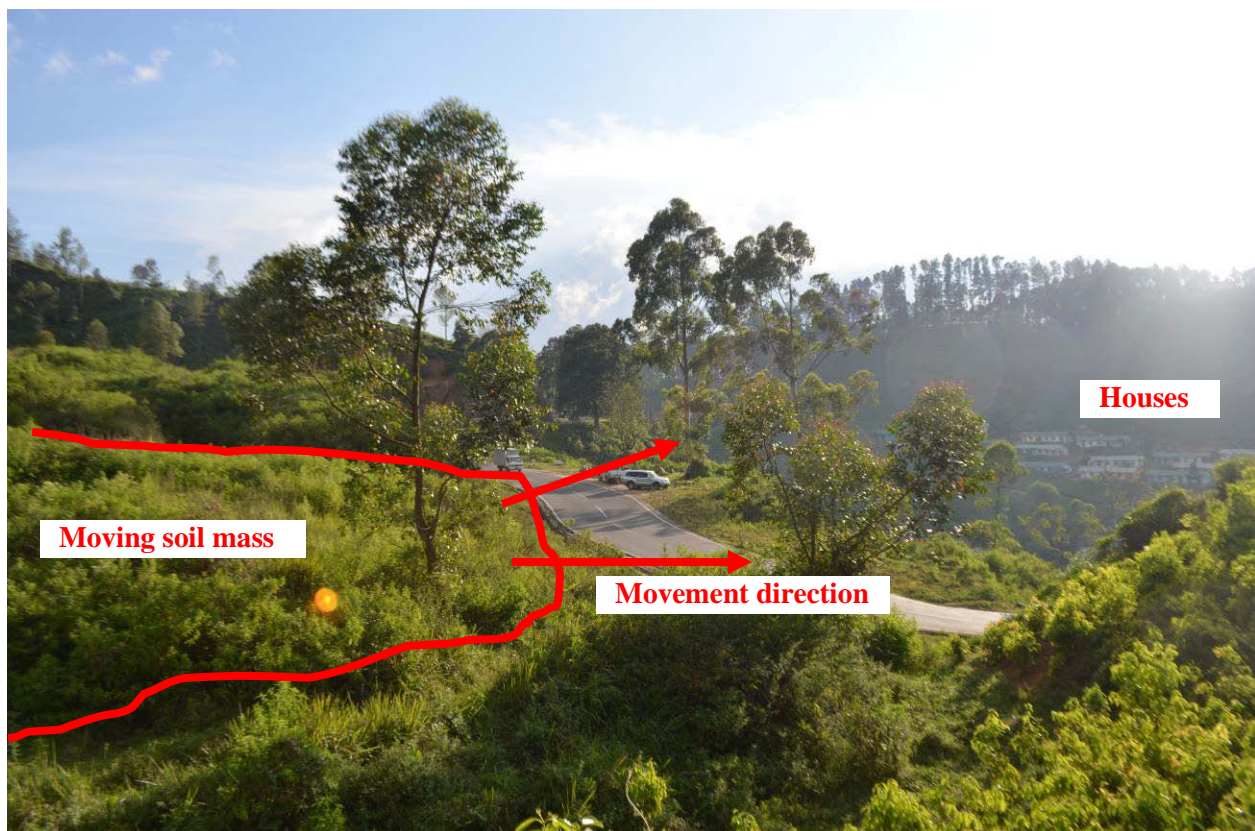
- Very slow movement of slope section along National Highway Route A6.
- Route A6 is a very important route for tea transportation.
- Very clear signs of slope movements are still not found but the slope is suspected to be moving by Sri Lankan officials. They tried to conduct magnetic survey to monitor slope movements but unfortunately there was no rain during that time, hence they could not confirm the movement.
- Tilt sensors and moisture sensors can provide a better picture.
- A small water catchment has been found at the rear end of the slope. It is expected to be acting as a water charge for moving slope.

Figure 15: Overview of Kahagolla landslide site.

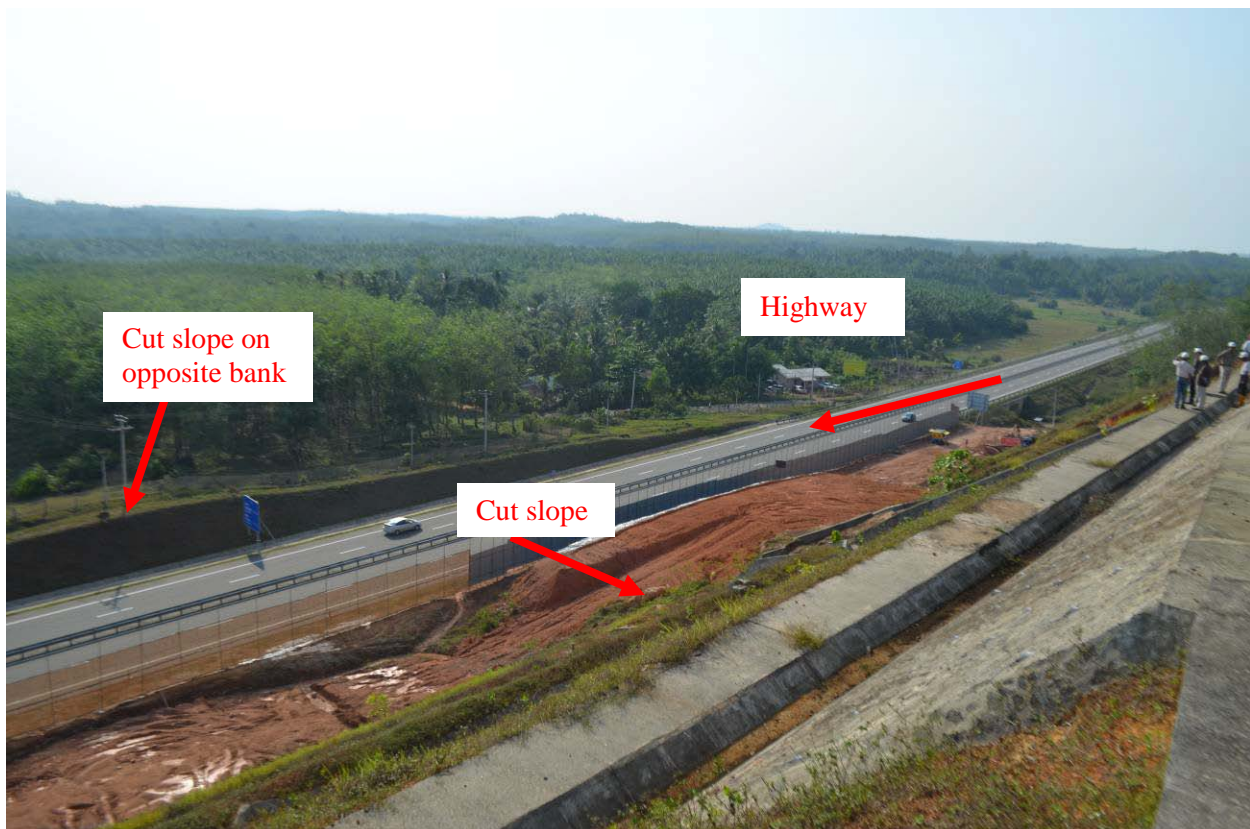
- Failed slope was part of a cut slope, which was cut to accommodate the highway at its center (Fig. 15).
- Recently they have installed three piezometers to monitor the fluctuation of water table. The piezometers have been installed 7 m above road level and they have found that the water level is generally 1-2 meter above road level.

Figure 15: Cut slope to accommodate the highway

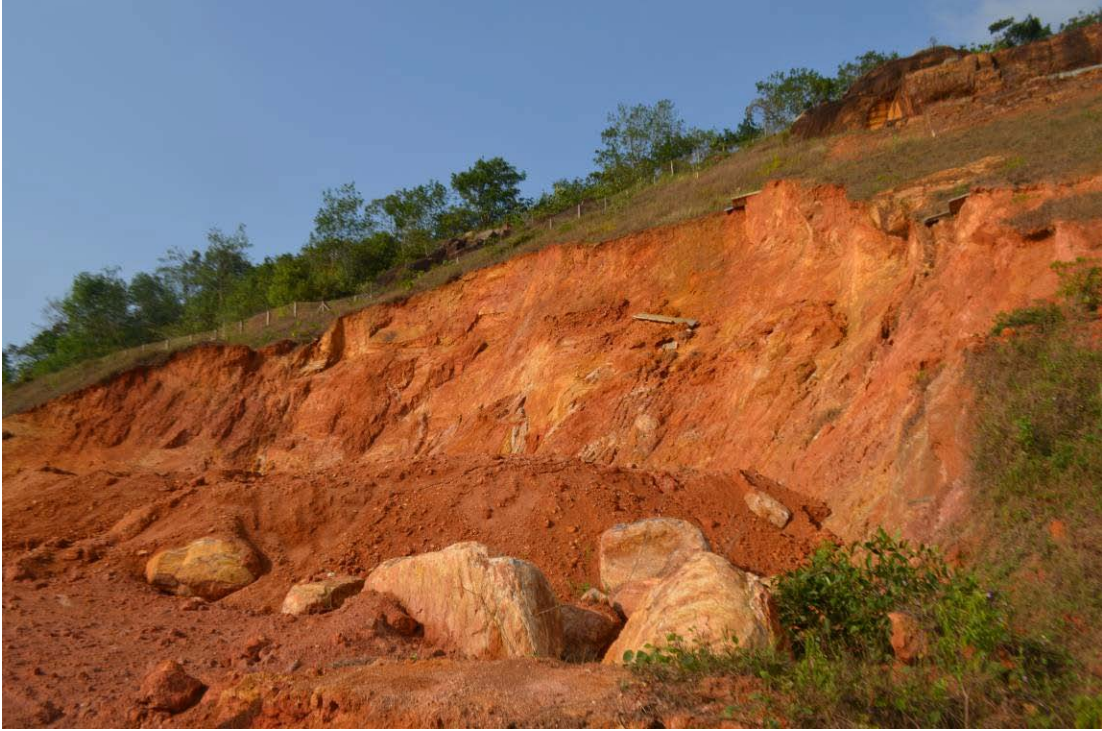
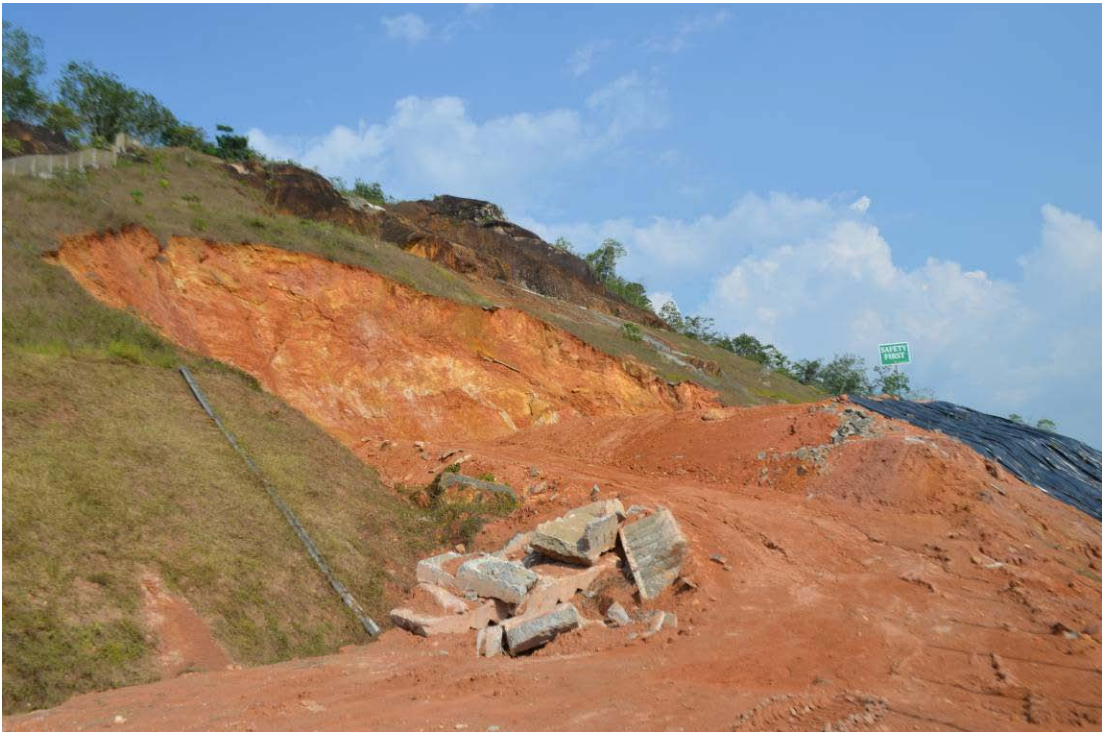
- Southern expressway was opened for traffic in 2011.
- During November 2012, after one week of continuous rainfall (~ 345 mm), a large slope failure occurred along its bank.

- Previously installed water drains were probably choked during heavy rainstorms hence pore water could not dissipate and led to failure of slope.
- Currently planned restoration method includes soil nailing in the already failed part of the slope in order to strengthen it. Whereas an improved water drainage facility in the form of weep holes is being provided on either sides of the failed slope. This is expected to improve drainage, dissipate pore water pressure and hence reduce the risk of slope failure.

Figure 16: Overview of Dodangoda landslide site.
