- The sketch map of field investigations in Wenchuan earthquake hit region, Chengdu City.

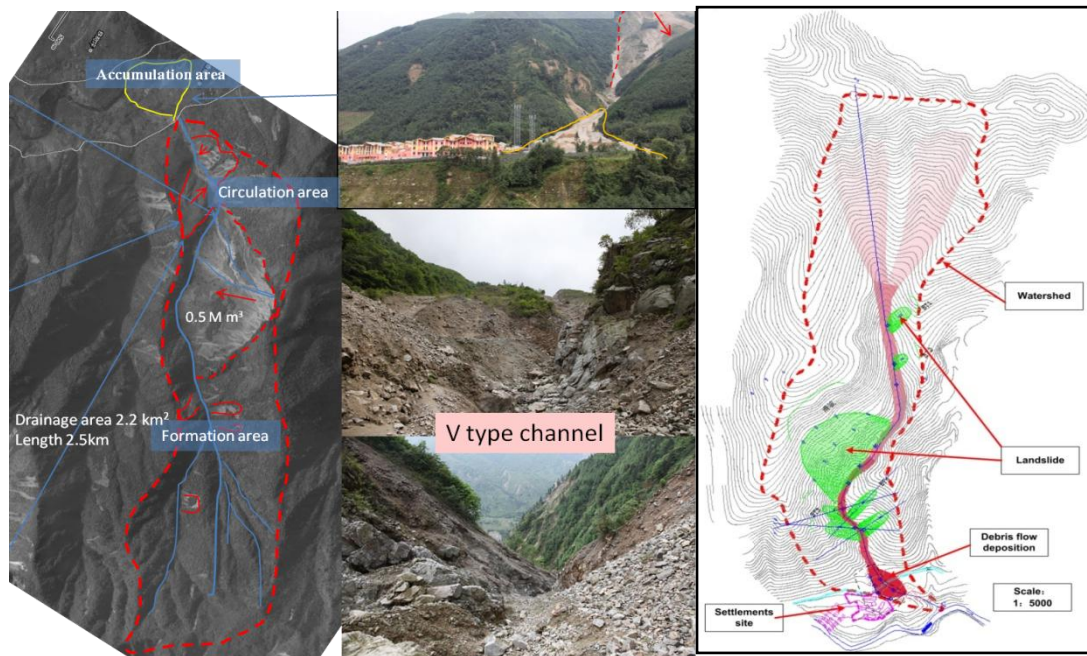
Fig. 4 Debris flow scope at Yin Dong Zi Gully

In the history of Yin Dong Zi Gully, there was nearly no debris flow occurrences. However, after the Magnitude 8, Wen Chuan Earthquake in 2008, a lot of slope failures and landslides occurred, which supplied a great amount of source for the sequential debris flows. In the midnight of Jun. 17th, 2009, a heavy rainfall brought a precipitation of 219 mm in 6 hours. The main precipitation concentrated between 3 am to 6 am, with a rainfall intensity of 60 to 70 mm/h. This rainfall triggered the first big debris flow in this gully. The flow velocity at the gully mouth was approximately 2 to 3 m/s, while the height was about 3 m, and the maximum discharge was about 100 m³/s. The field investigation after the debris flow showed that the debris deposition beyond the gully mouth was about 3×10⁴m³, while the debris deposition inside the gully was about 5×10⁴m³. The particle in the debris deposition has an averaged diameter of 10-20 cm, while the maximum particle size is about 1.0 m. Most particles are of the angular shape.

Starting from 2009, each year in Yin Dong Zi Gully some debris flows of big and small scales occurred frequently. The newest debris flow occurred in June, 2013, which has a greater scale than the one in 2009, see Fig4 and5. The debris flow in 2013 swallowed the newly constructed dam and drainage groove.

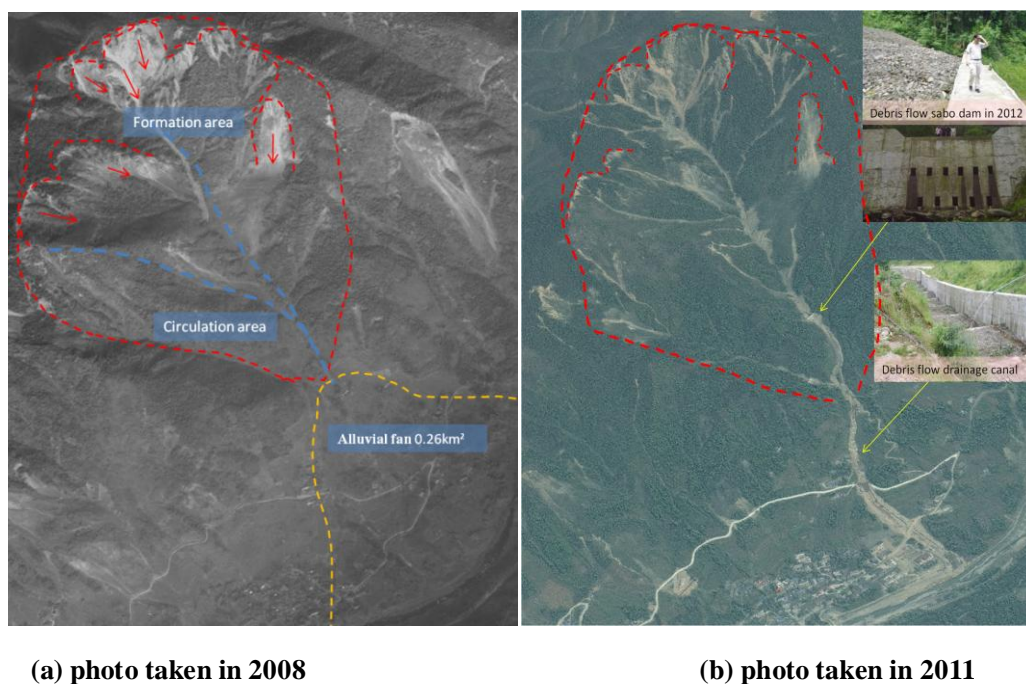
Starting from 2009, each year in Gangou Gully debris flows of big and small scales occurred frequently. The newest debris flow occurred in July, 2013, the newly constructed sabo dam and the bridge cross the gully were completely buried by the debris. Fig6 -8.

Fig.6 Debris flow in Gangou Gully

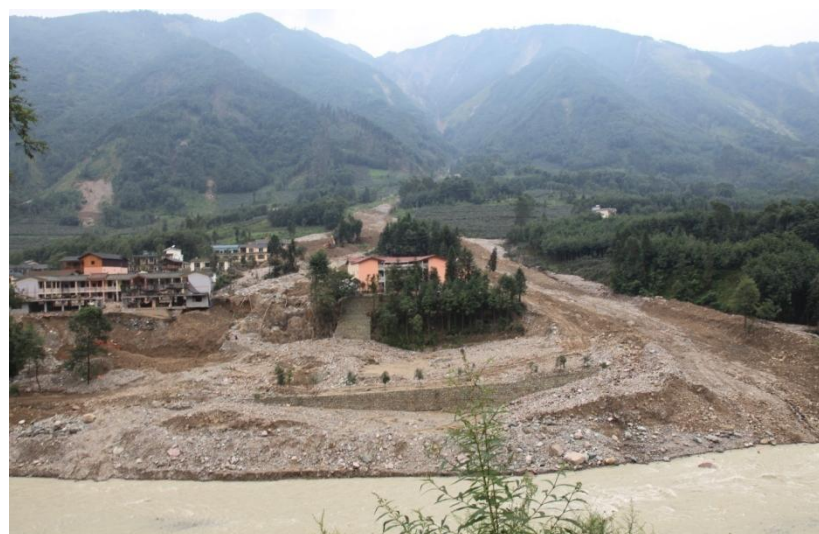
Fig.7 Debris flow occurred in Gangou Gully, August 18, 2010

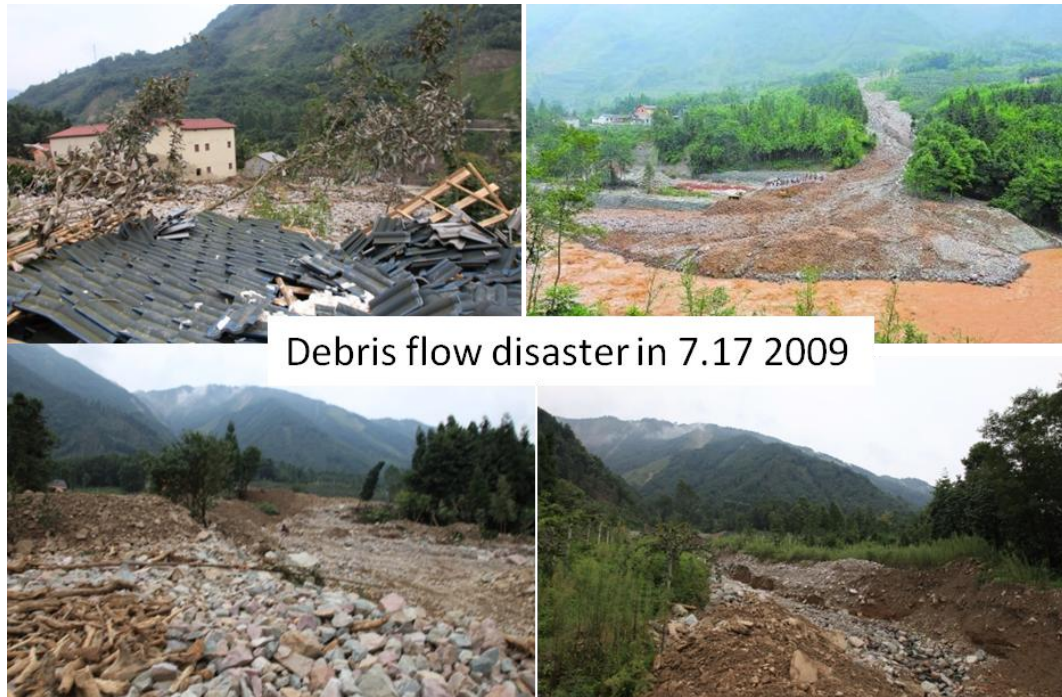
There was no debris flow record in the history of Gangou Gully. after Wenchuan Earthquake, 6 major slope failures occurred in the watershed, which supplied a great amount of source for the upcoming debris flows. In July. 17th, 2009, a heavy rainfall with a total rainfall of 219 mm triggered debris flow in this gully. The flow velocity at the gully mouth was

approximately 3.5 m/s, while the height was about 2.1 m, The field investigation after the debris flow showed that the debris deposition beyond the gully mouth was about $3.2 \times 10^4 \text{ m}^3$, while the debris deposition inside the gully was about $35 \times 10^4 \text{ m}^3$. The particle in the debris deposition has an averaged diameter of 8-30 cm, most particles are of the angular shape. The debris flow in 2009 caused 2 persons dead and the total economical loss is 30 m CNY.

Fig.6 Debris flow occurred in Gangou Gully,2009

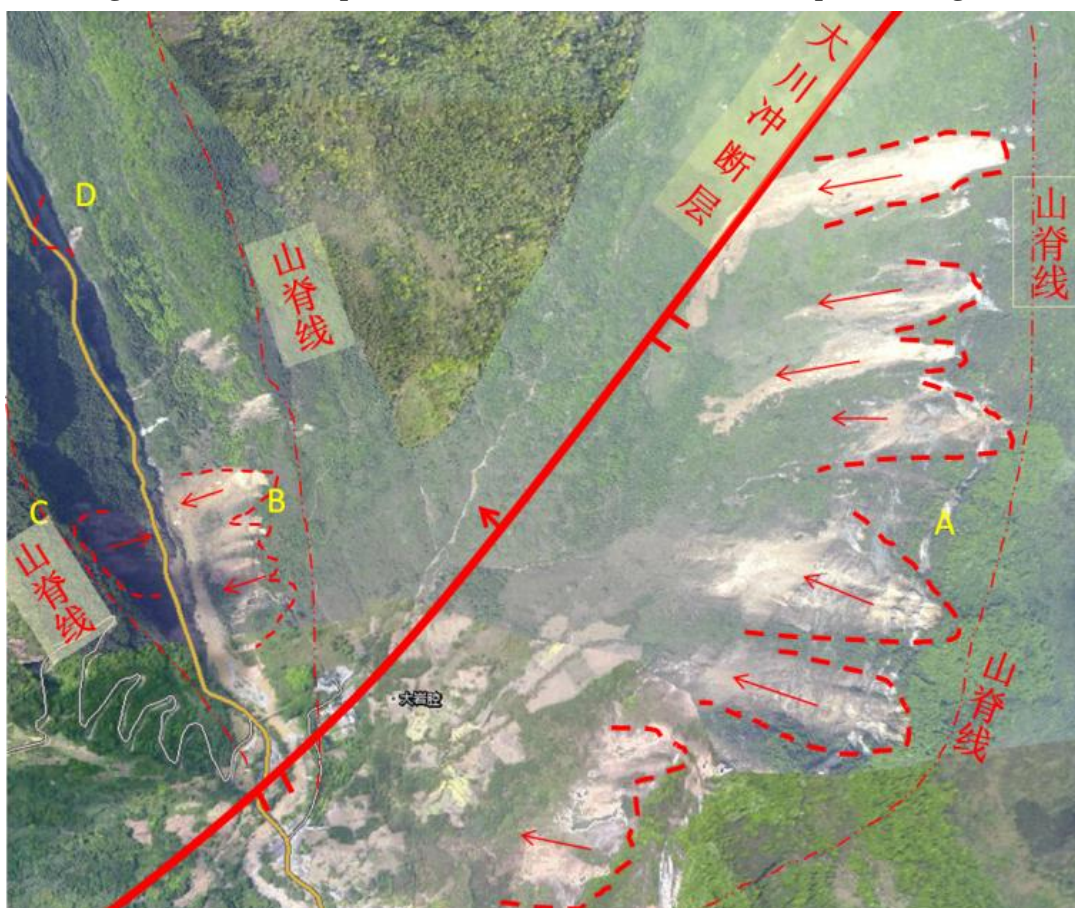
Fig.8 Collapses in Dayanqiang, Shuangshi County

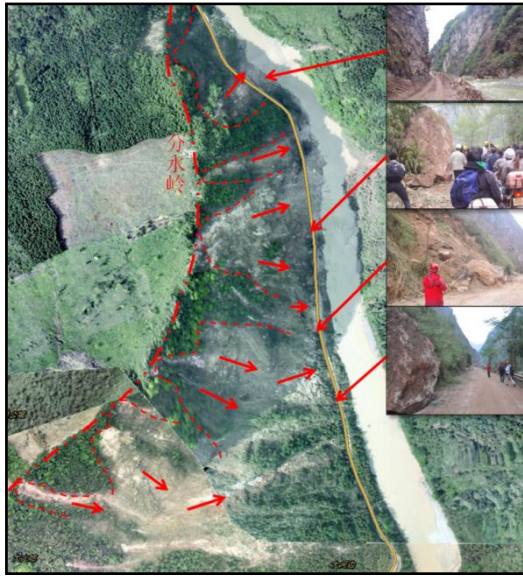
Fig.9 Collapses in Jinjiguan, Baosheng County

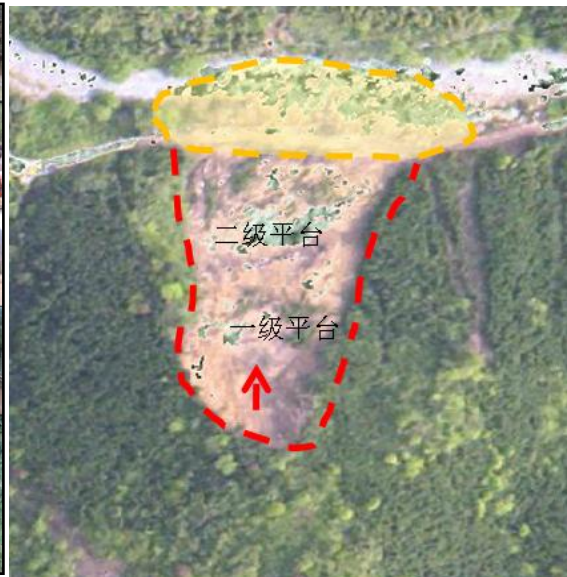
Fig.10 Qianshuigou landslide in Shuangshi County.

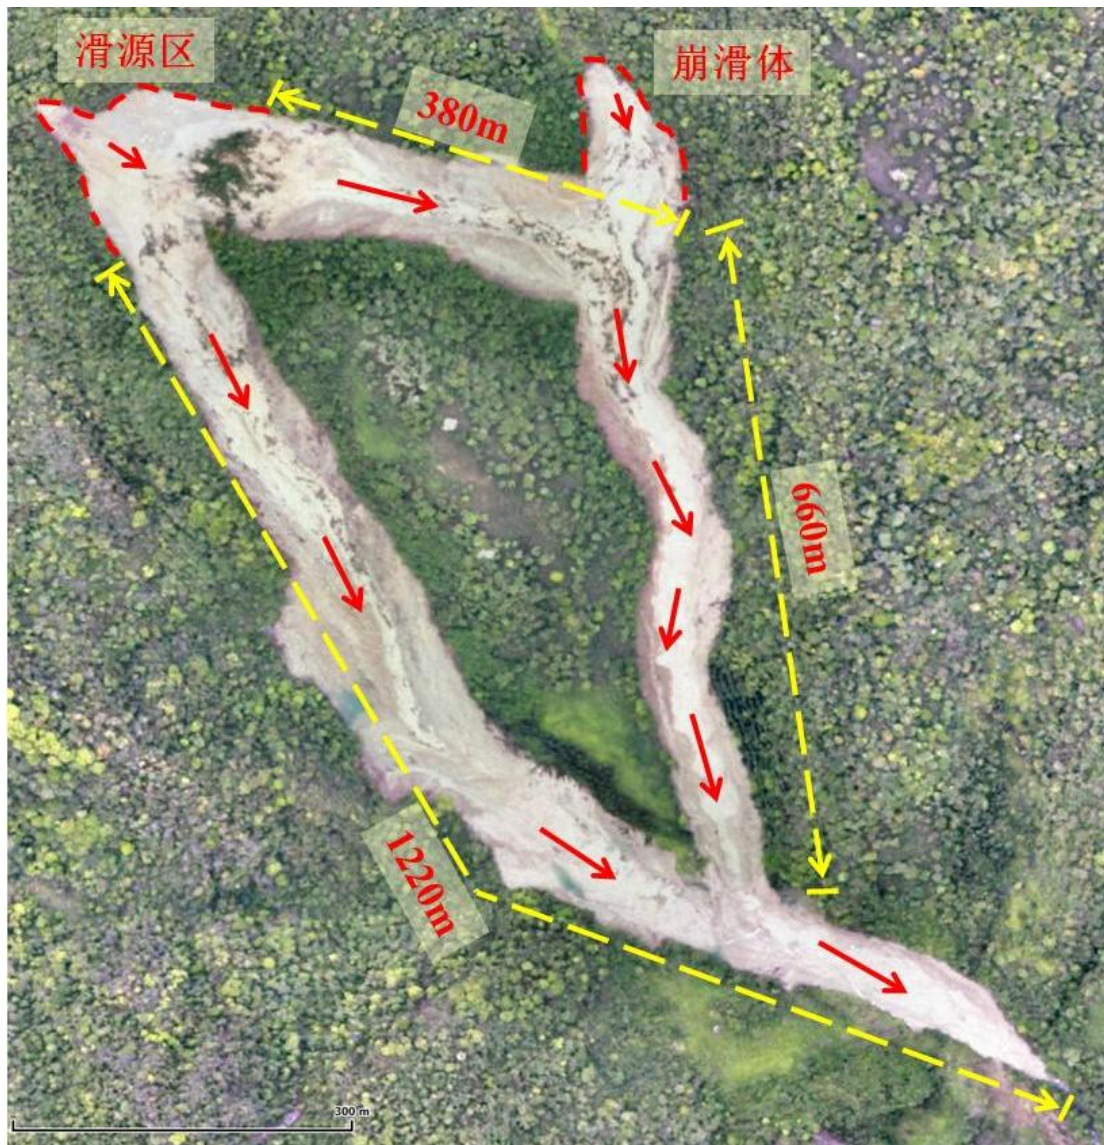
Fig.11 Tangjiagou long run-out landslide in Tianquan County.

Fig.11 illustrates one of a high-speed landslide and debris flow that occurred at the Tangjia gully in Tianquan County; location at (102.471_E, 30.091_N) in the Damiao Village, Laochang county. The Tangjia gully debris flow was triggered by the main shock of Ya'an earthquake. The elevation of debris flow ranges from 935m to 2060m. Under the influence of the landform, the landslide was split up into two suitable channel moving down on the left and right sides, and the slip mass changed into debris flow in the motion. Its length is about 80m, and the width is about 110m. The estimated volume of the debris flow is about $200 \times 10^4 \text{ m}^3$.

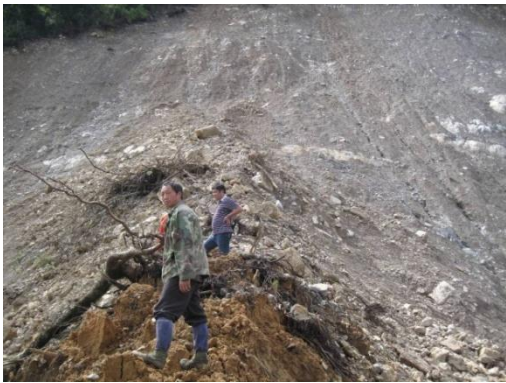
Photo.2 The top of Large collapse mountain

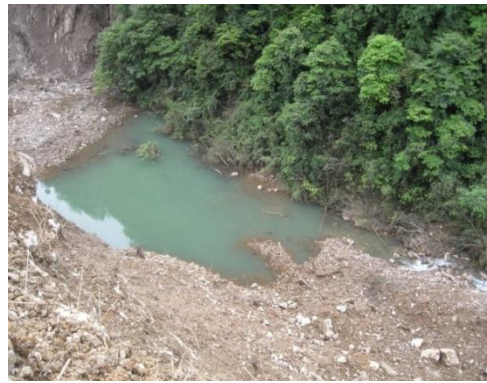
Photo.3 Dammed lake

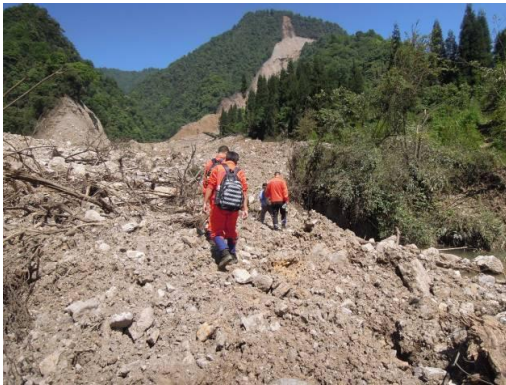
Photo.4 deposit in the gully

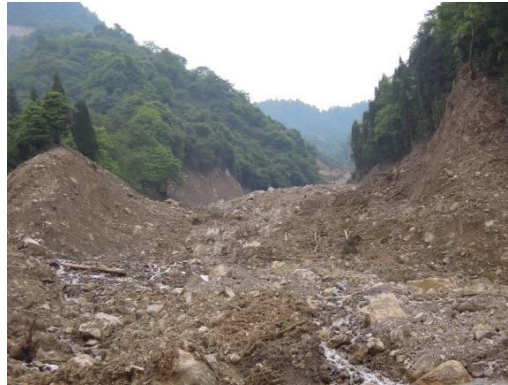
Photo.5 deposit in the gully
