Site Investigations in Sri Lanka

Objective: Site investigations and feasibility studies for installing landslide monitoring instruments at various JICA funded sites in Sri Lanka

Location: Nuwara Eliya, Sri Lanka

Duration: March 20th to March 23rd, 2014

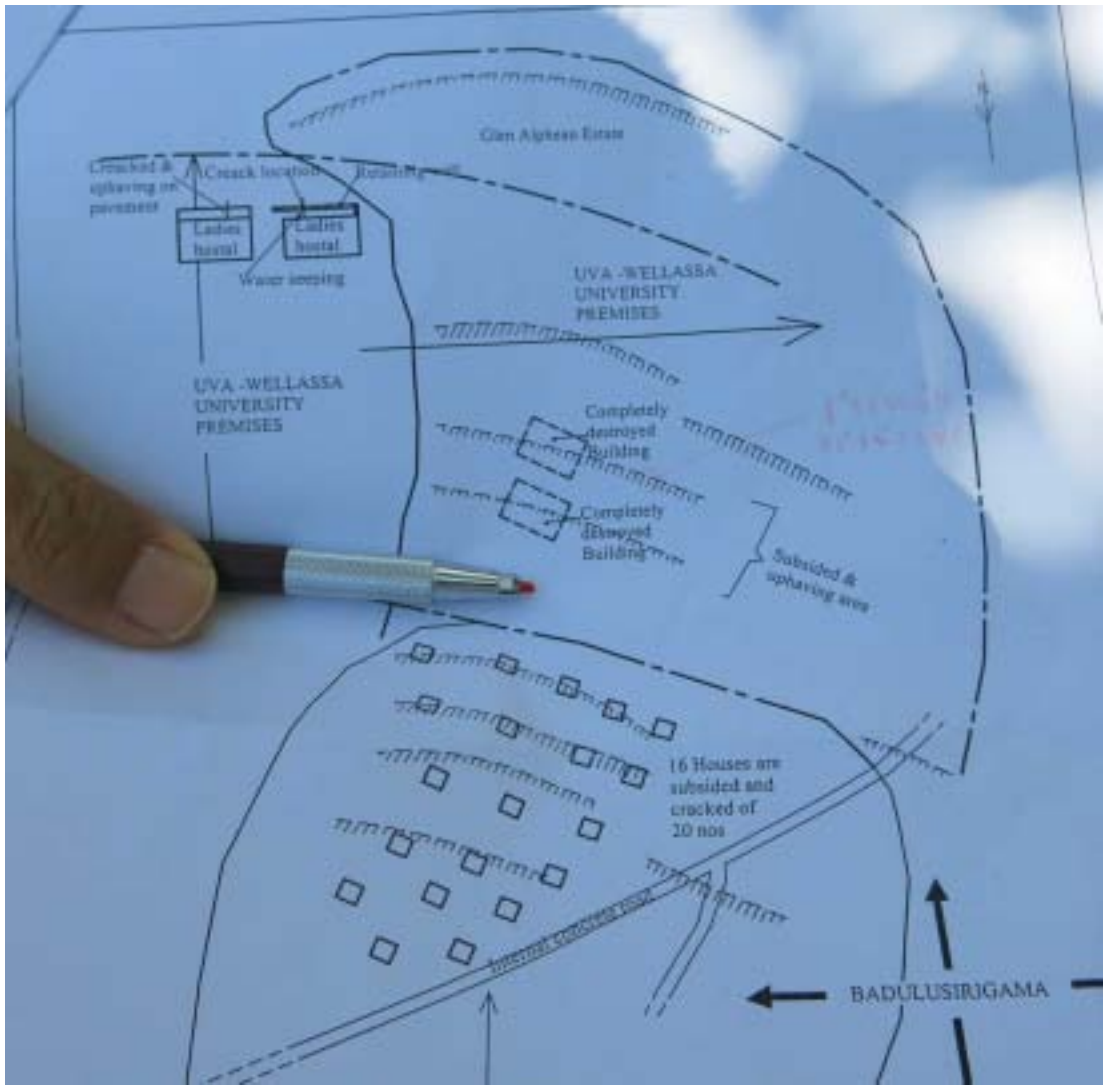
Figure 1: Sketched plan of the affected site.

- During heavy rain showers in December 2010 through January 2011, cracks started appearing in several houses situated in the landslide area.
- Until now 16 houses have totally subsided whereas another 20 houses have developed severe cracks.

- Overall length of the landslide is quite large as approximately 1 km strip of land appear to be moving.
- Cracks are clearly visible at various locations on the slope surface. Movement of the soil is well beyond 1 m at various such crack locations.

- Ground water table appears to be quite shallow (Fig. 4). Thus even small rainfall can potentially trigger rapid movement.
- Restricting the movement of such a massive slope may not be possible. However, monitoring instruments can help in identifying the risk involved and issue early warning to minimize damages.

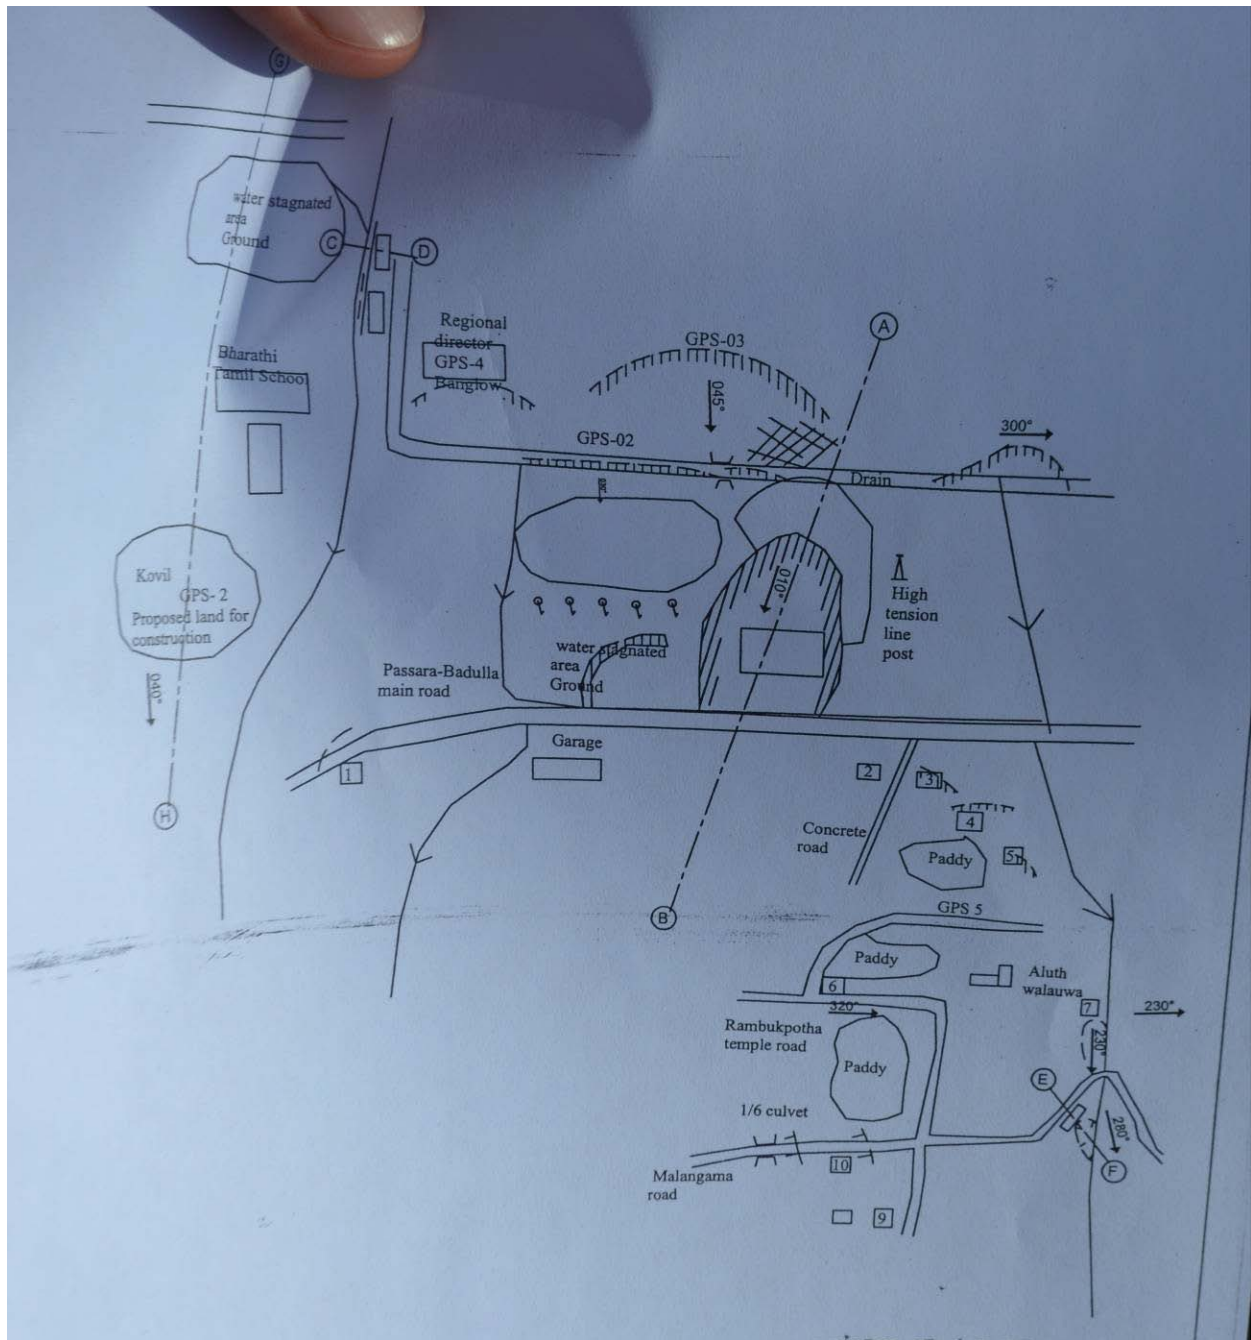
Figure 9: Sketched plan of affected area.

- Failure triggered during December 2010 and January 2011 storms.
- Very high annual rainfall (~ 3500 mm) in this area.
- Very heavy showers (165~170 mm) were observed during the said rainy season.
- Bungalow near the top of slope (location: GPS-4 in Fig. 9) was severely damaged due to slope movements.
- Some parts of the road which is running through the slope surface (location: GPS-2 in Fig. 9) have collapsed due to gradual slope movement.

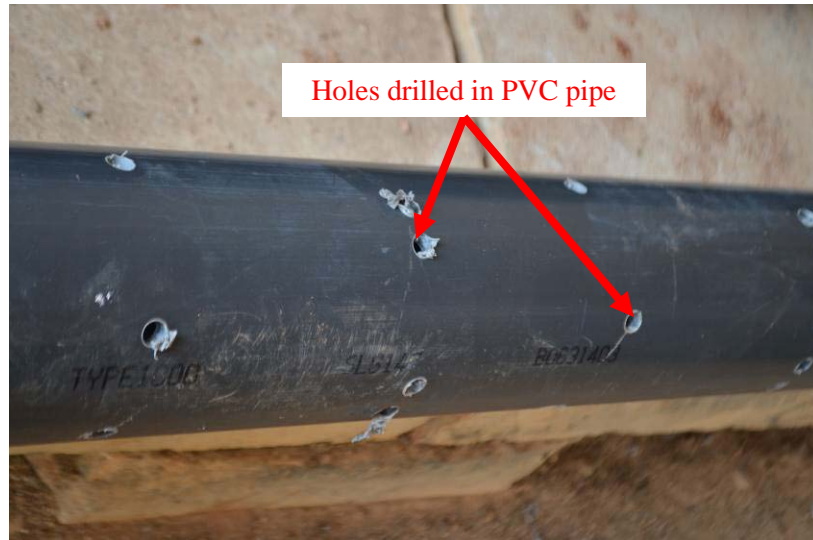
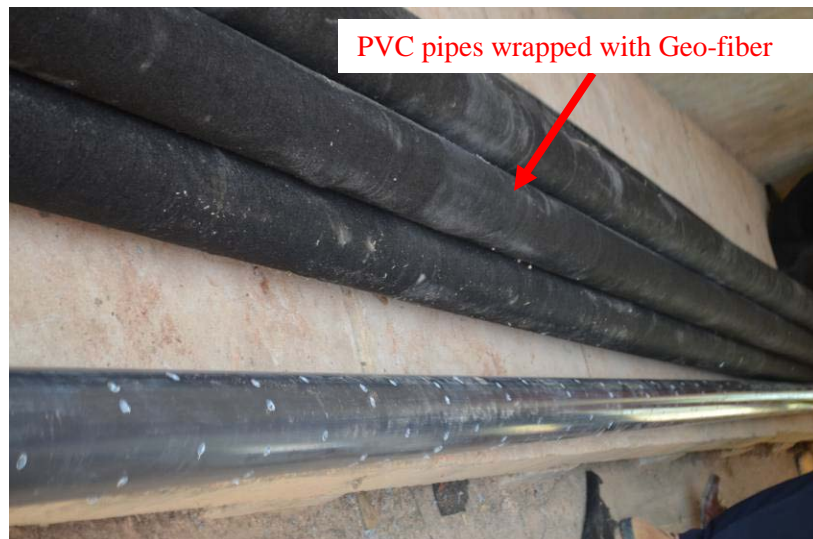
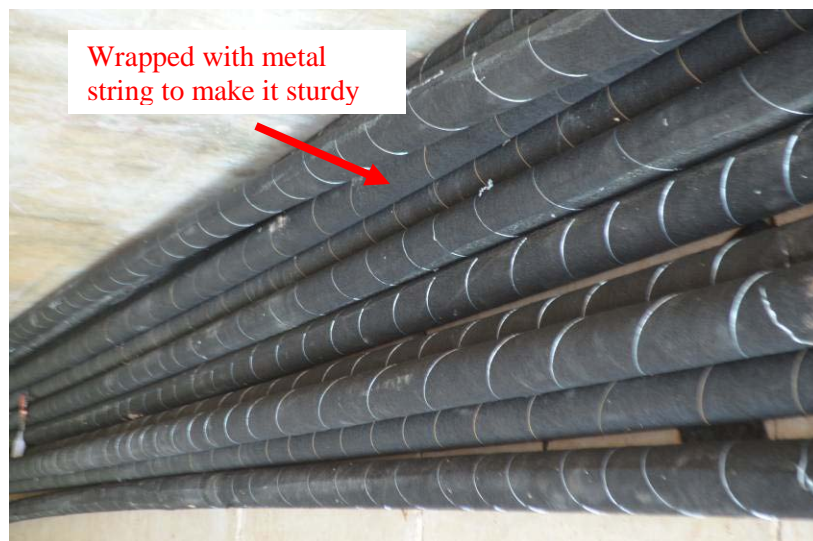
Figure 17: Conversion of ordinary PVC pipes into landslide drainage pipe.

- Previously installed water drains were probably choked during heavy rainstorms hence pore water could not dissipate and led to failure of slope.
- Currently planned restoration method includes soil nailing in the already failed part of the slope in order to strengthen it. Whereas an improved water drainage facility in the form of weep holes is being provided on either sides of the failed slope. This is expected to improve drainage, dissipate pore water pressure and hence reduce the risk of slope failure.

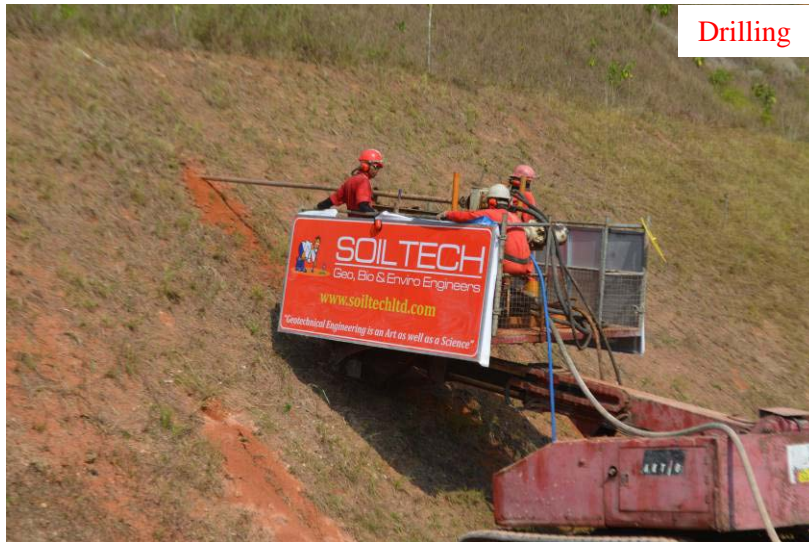
Drilling

Figure 18: Installation of drainage pipes on the slope.
