- The sketch map of field investigations in Wenchuan earthquake hit region, Chengdu City.

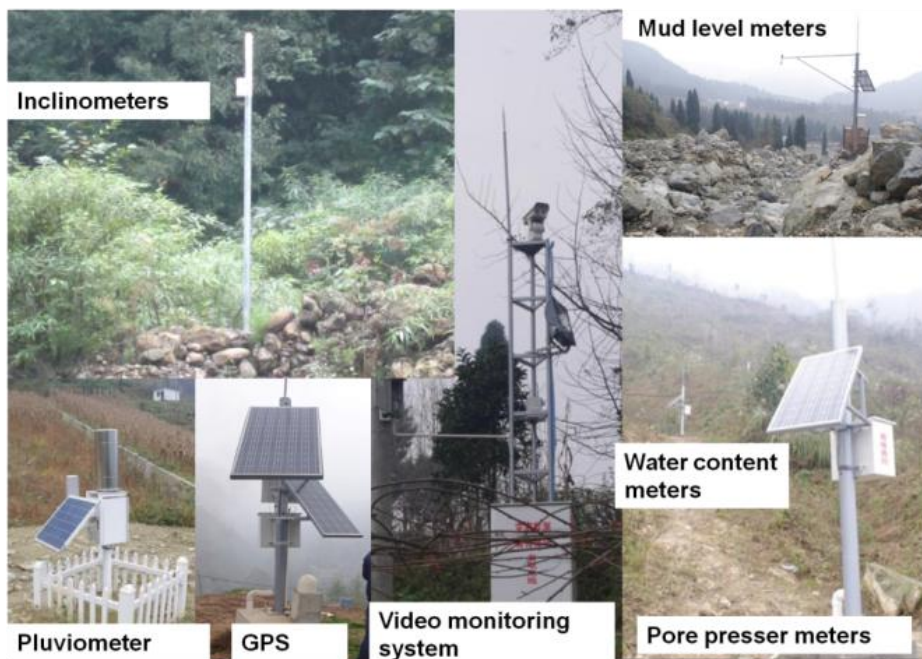
Fig.3 Photos of Site-specific real-time monitoring and pre-warning system

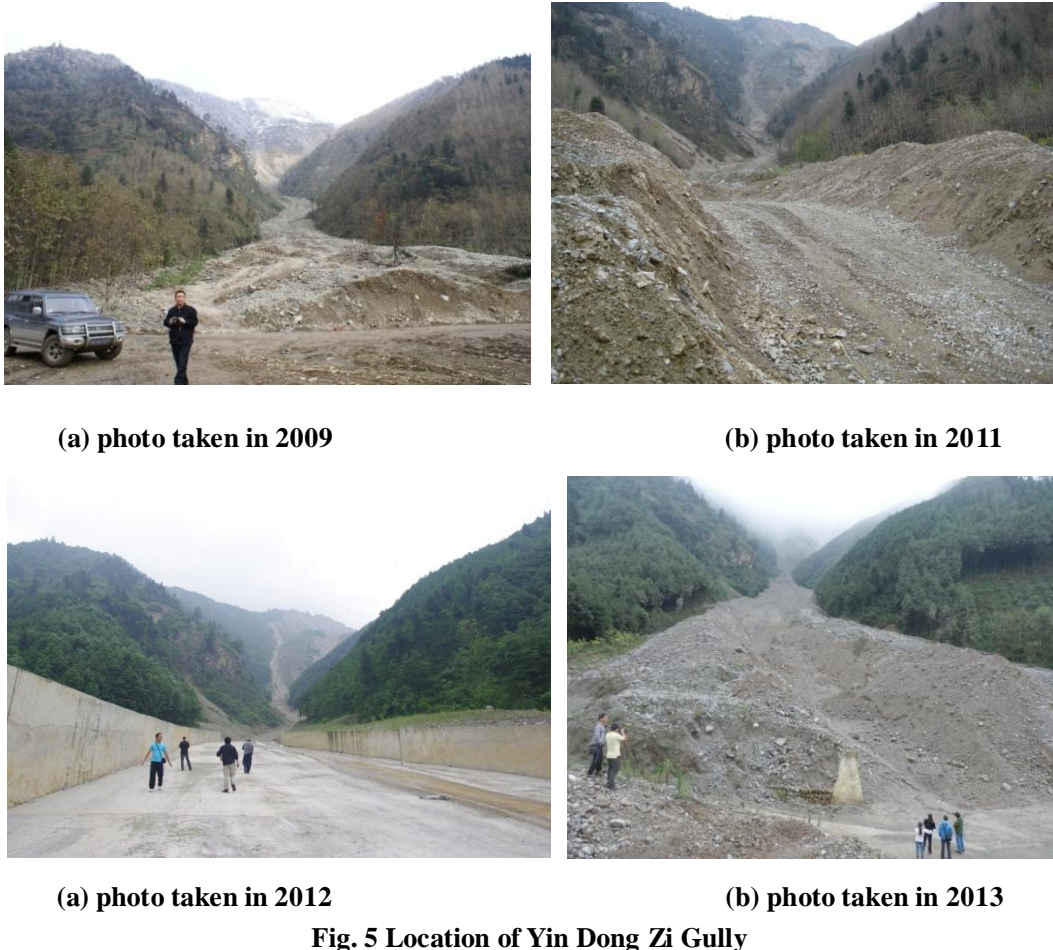
Fig. 5 Location of Yin Dong Zi Gully

Starting from 2009, each year in Yin Dong Zi Gully some debris flows of big and small scales occurred frequently. The newest debris flow occurred in June, 2013, which has a greater scale than the one in 2009, see Fig4 and5. The debris flow in 2013 swallowed the newly constructed dam and drainage groove.

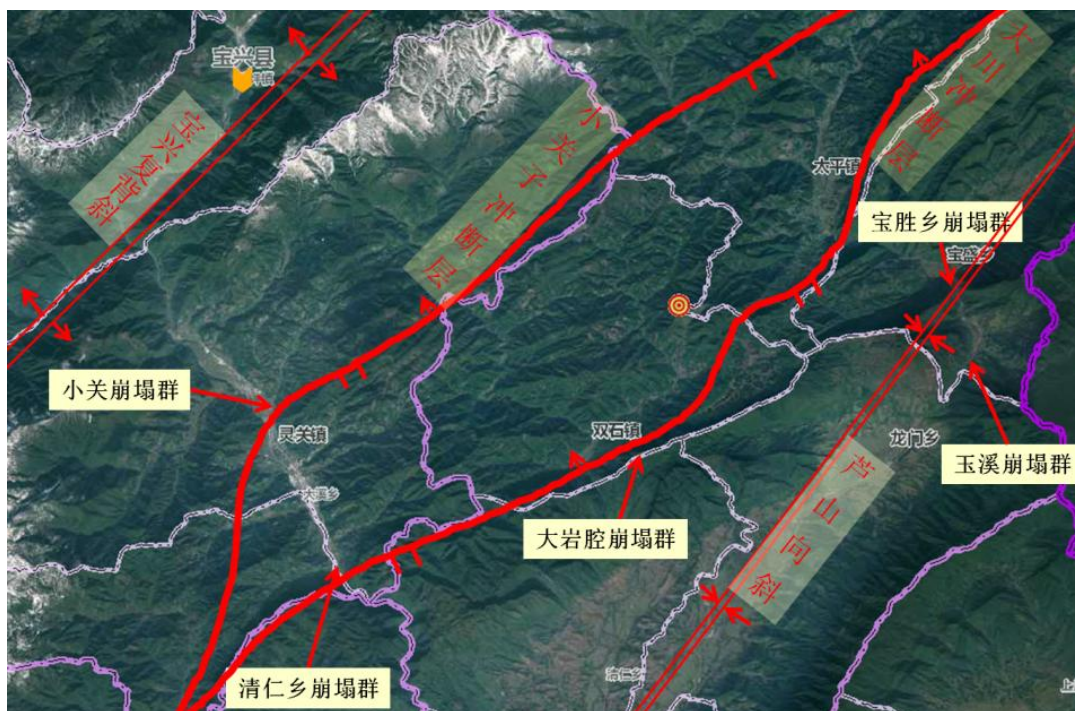
Ms 7.0 giant earthquake took place in Lushan County, Yaan City at 8:02, April 20th, 2013, which claimed 196 of lives, 21 of missing and effected 2M people, also induced large amount of secondary mountain hazards including collapses, landslides, etc. The most of secondary mountain disasters is collapses with small and median scale volume according to field investigation. Five principal types of secondary mountain disasters consisting of conglomerate collapses, sandstone collapses, carbonate stone collapses, landslides and long run-out landslide-avalanche were proposed. The regional geological environment and structure was regarded as the primary element and the large amount of loosen materials are easy for occurring debris flows and landslides triggering by the storm and continuous rainfall, which will seriously threat the reconstruction and lives in the rainy season for decades, therefore the post-earthquake effect as well as the monitoring and pre-warning strategy should be carry out in earthquake area and especially in reconstruction settlements.

Fig.7 Distribution map of mountain hazards in Lushan earthquake hit region
